ARTICLE NO. 1

RESPECTING THE MARKS – THE VITAL THIRD STEP IN DAMAGE PREVENTION

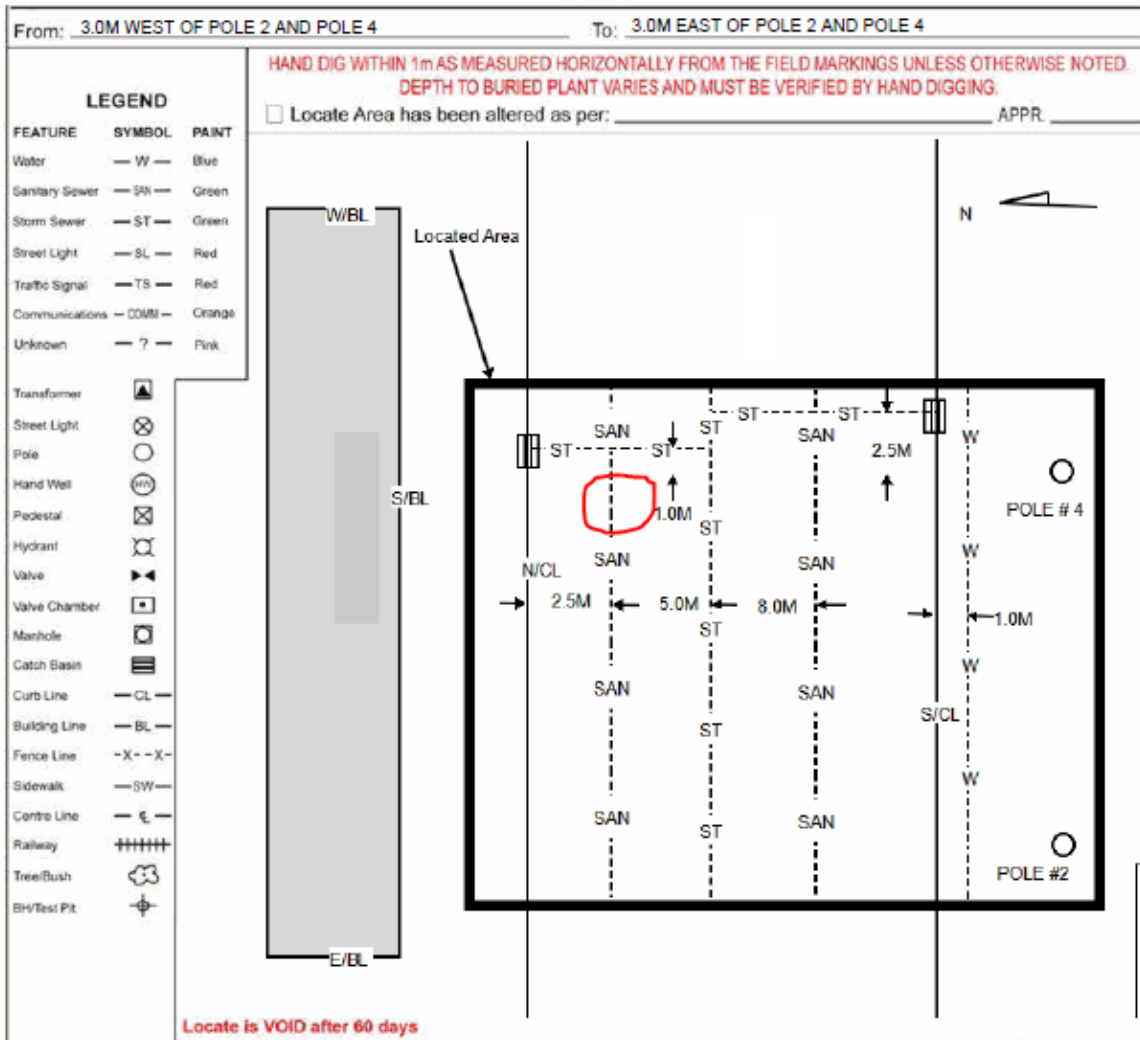
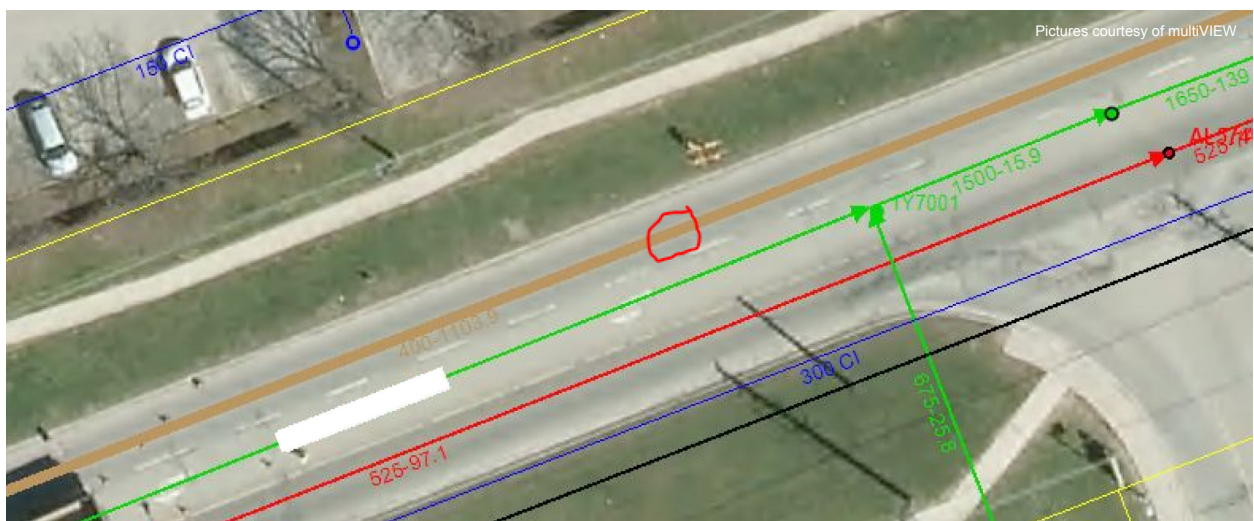
So what went wrong? The contractor had dug down 4-5 feet and when nothing was detected, continued to drill under the assumption that the force main was positioned at a depth that would not conflict with the excavation. Unfortunately, this assumption was wrong and the excavator did in fact make contact.

Photo caption: Prior to excavation, the utility had been accurately located and the work area had been marked. The markings and locate report correctly reflected the data contained within the utility records. However, damage occurred as a result of not respecting the marks or utilizing safe excavation practices.

In this situation, the contractor relied on assumptions and ignored key principles of respecting the marks. The incident could have been easily avoided if the contractor had taken some vital damage prevention steps. For example, prior to drilling, the contractor should have performed test holes to determine the location of utilities within the project site so that minimum vertical clearances could have been created and a safe path could have been planned for the drill head of the directional drilling machine.

The contractor should have also leveraged hand tools to safely expose the utility prior to commencing the drilling activities. Furthermore, the contractor had the option of contacting a utility locate services company to complete Subsurface Utility Engineering (SUE) Quality Level B (utility locating) and Quality Level A (vacuum excavation) to verify that the utility depicted on the locate report was in fact reflective of city records.
