Case Study

Real-Time Subsurface Data Empowers Safe Excavation

REAL-TIME SUBSURFACE DATA empowers safe excavation

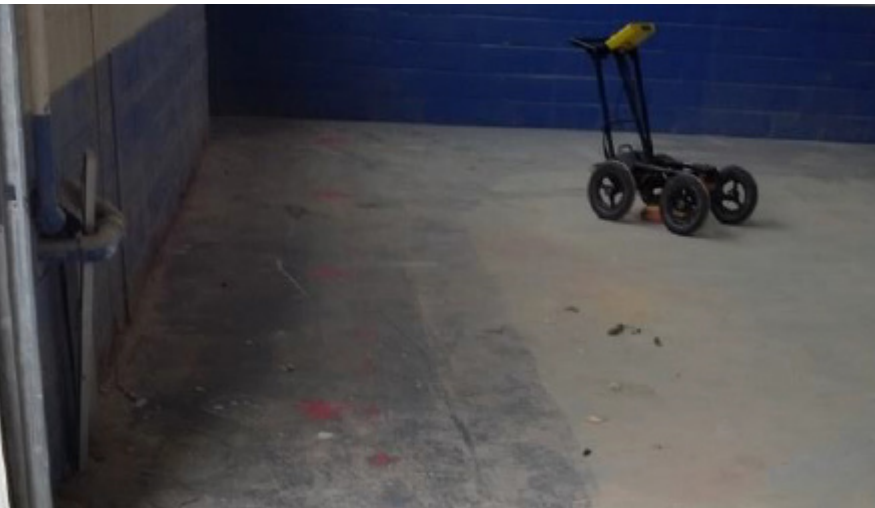
Unlike X-Ray, GPR transmits harmless electromagnetic waves into the structure and analyzes the reflected energy to create a profile of subsurface features. It can assess slab thickness and detect anomalies deep below the surface that indicate the presence of utilities and other features. No clearance area is required and it can be performed during regular business hours. Construction works can then continue immediately following the scan.

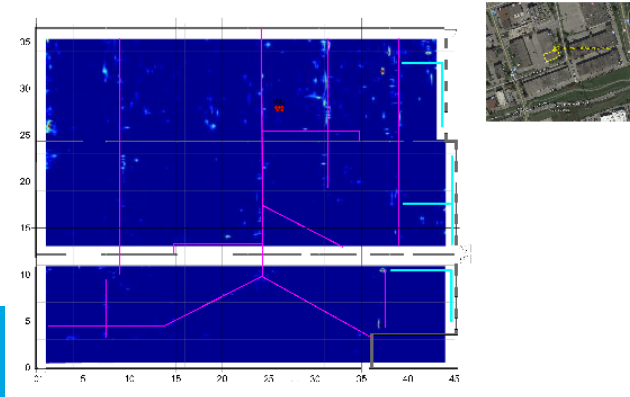
Depth contour maps are used to illustrate the depth of the utilities from the surface of the concrete slab to the top of the utility throughout the entire survey area.

Depth contour maps were created to illustrate the depth of the utilities from the surface of the suspended slab to the top of the utility throughout the entire survey area. Detailed interpretation results were made available digitally and compilation plan maps were provided along with a summary report. multiVIEW recommended that the results of the survey be correlated to the reference grid stations presented on the digital maps when physically locating the interpreted responses over the project site for intrusive testing, excavation or rehabilitation activities.

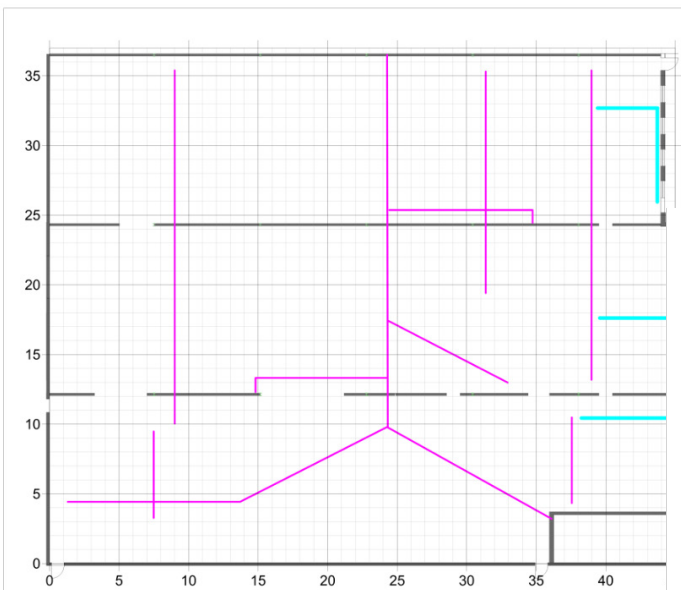
Drain lines indicated on the record data provided by Harrington & Associates are overlaid on the survey area and colour-coded based on the drain line type.

GPR features identified as large metallic piping beneath the concrete slab were determined to be HVAC ducts and were illustrated with light blue lines on the maps. Furthermore, drain lines indicated on the record data provided by Harrington & Associates were overlaid on the survey area and colour-coded based on the drain line type. The client was also provided with raw GPR data profile images to illustrate the findings.
